Case 358 : Narrative

Case Vehicle (A): 2003 Ford
Type: Taurus, 4-door sedan
Driver: 85-year-old male
CDC: 06-BLMN-1, 12-FREW-2

This is a fatal crash; the elderly driver of case vehicle (A) died from thoracic injuries sustained in a frontal impact with a tree.

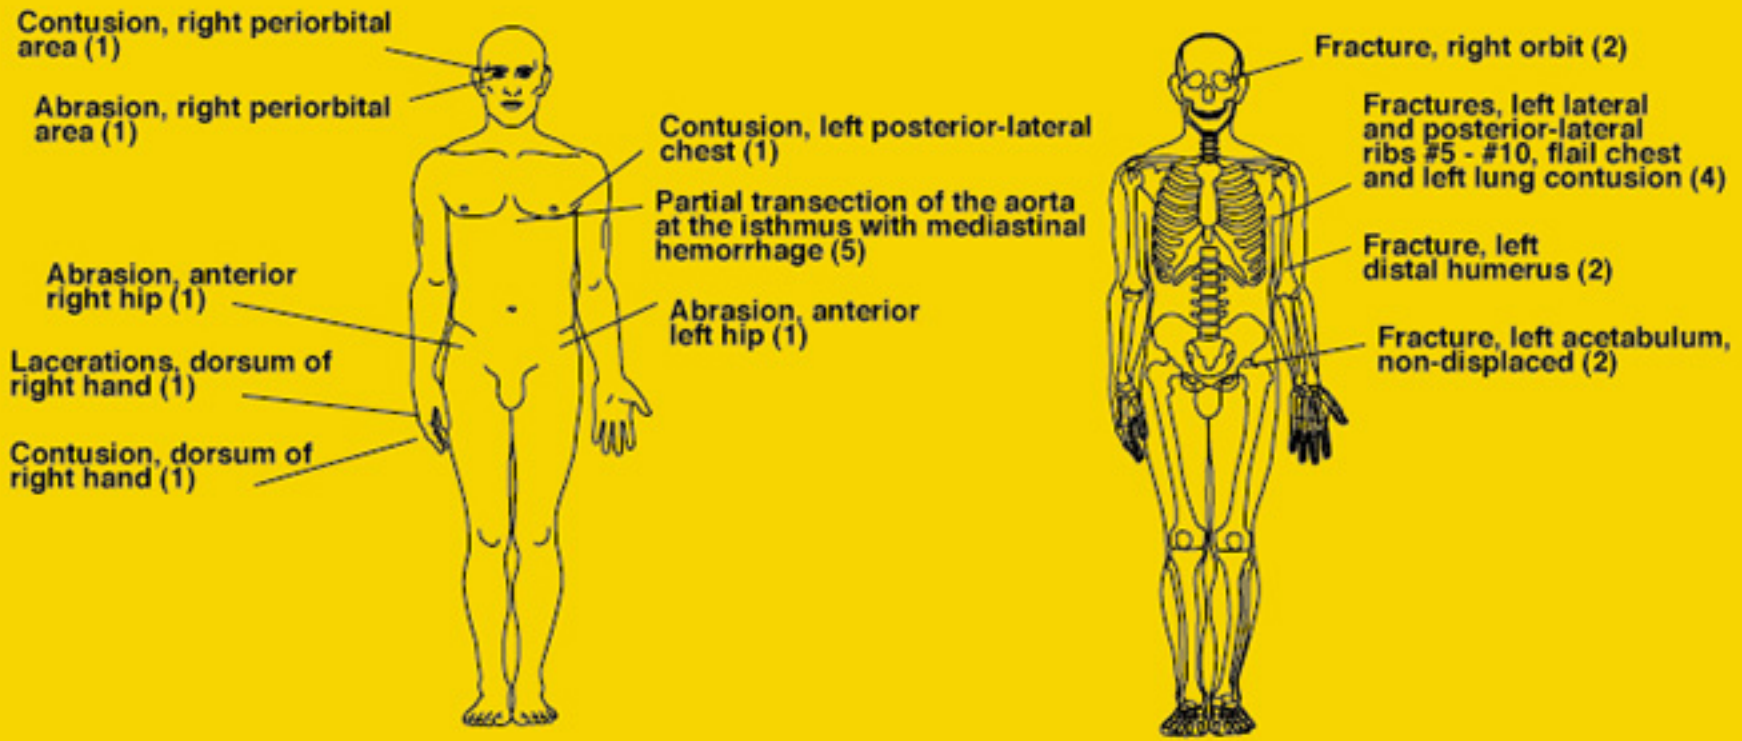
SEVERITY: MAIS - **5** ISS - **33**

FATAL - cause of death listed as "blunt chest trauma"

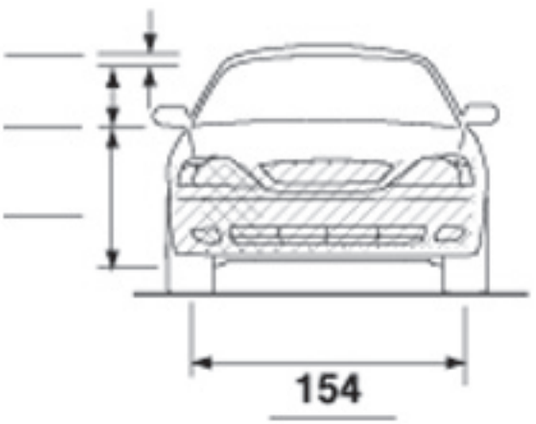
MEASUREMENTS IN CENTIMETERS

direct damage width = 45 cm
maximum crush = 40 cm

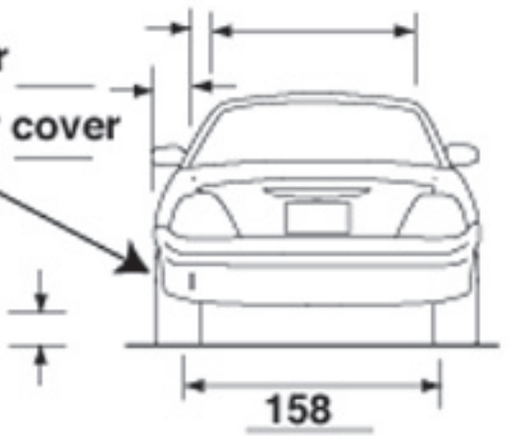
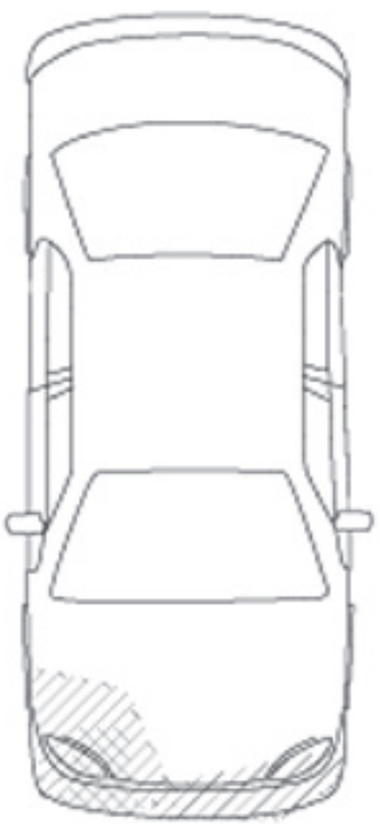
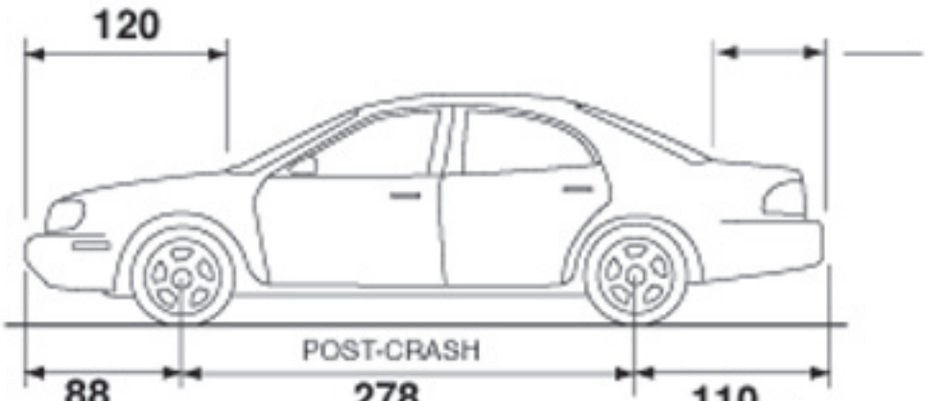
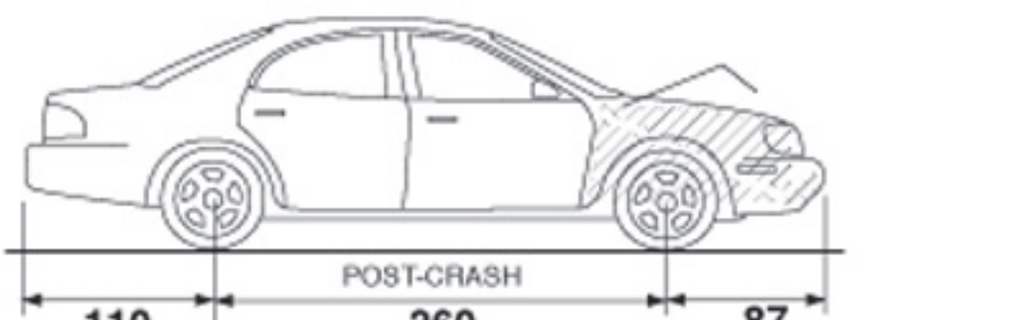
Direct damage to rear plane limited to a cut in the plastic bumper cover

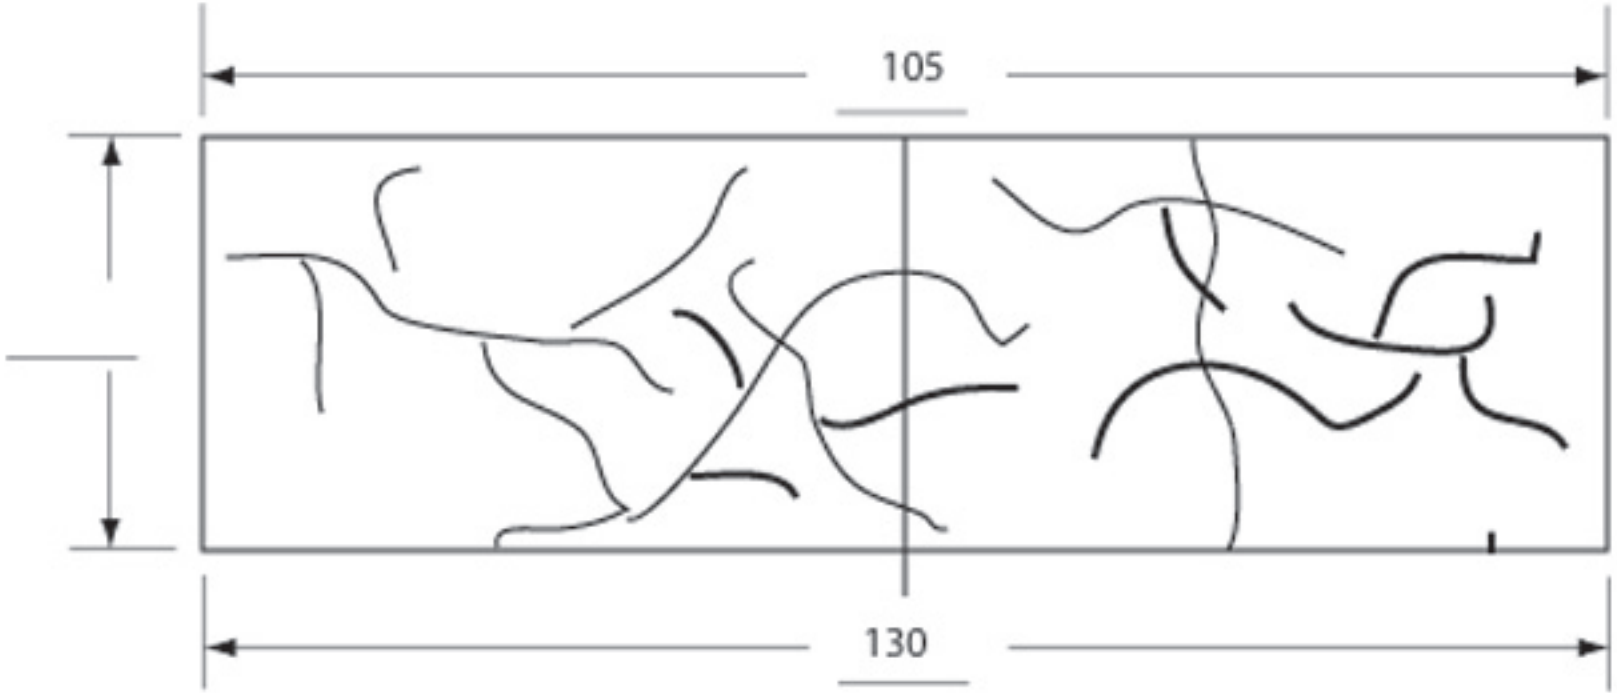
WINDSHIELD MARK ON CASE VEHICLE:

Unable to read W/S mark

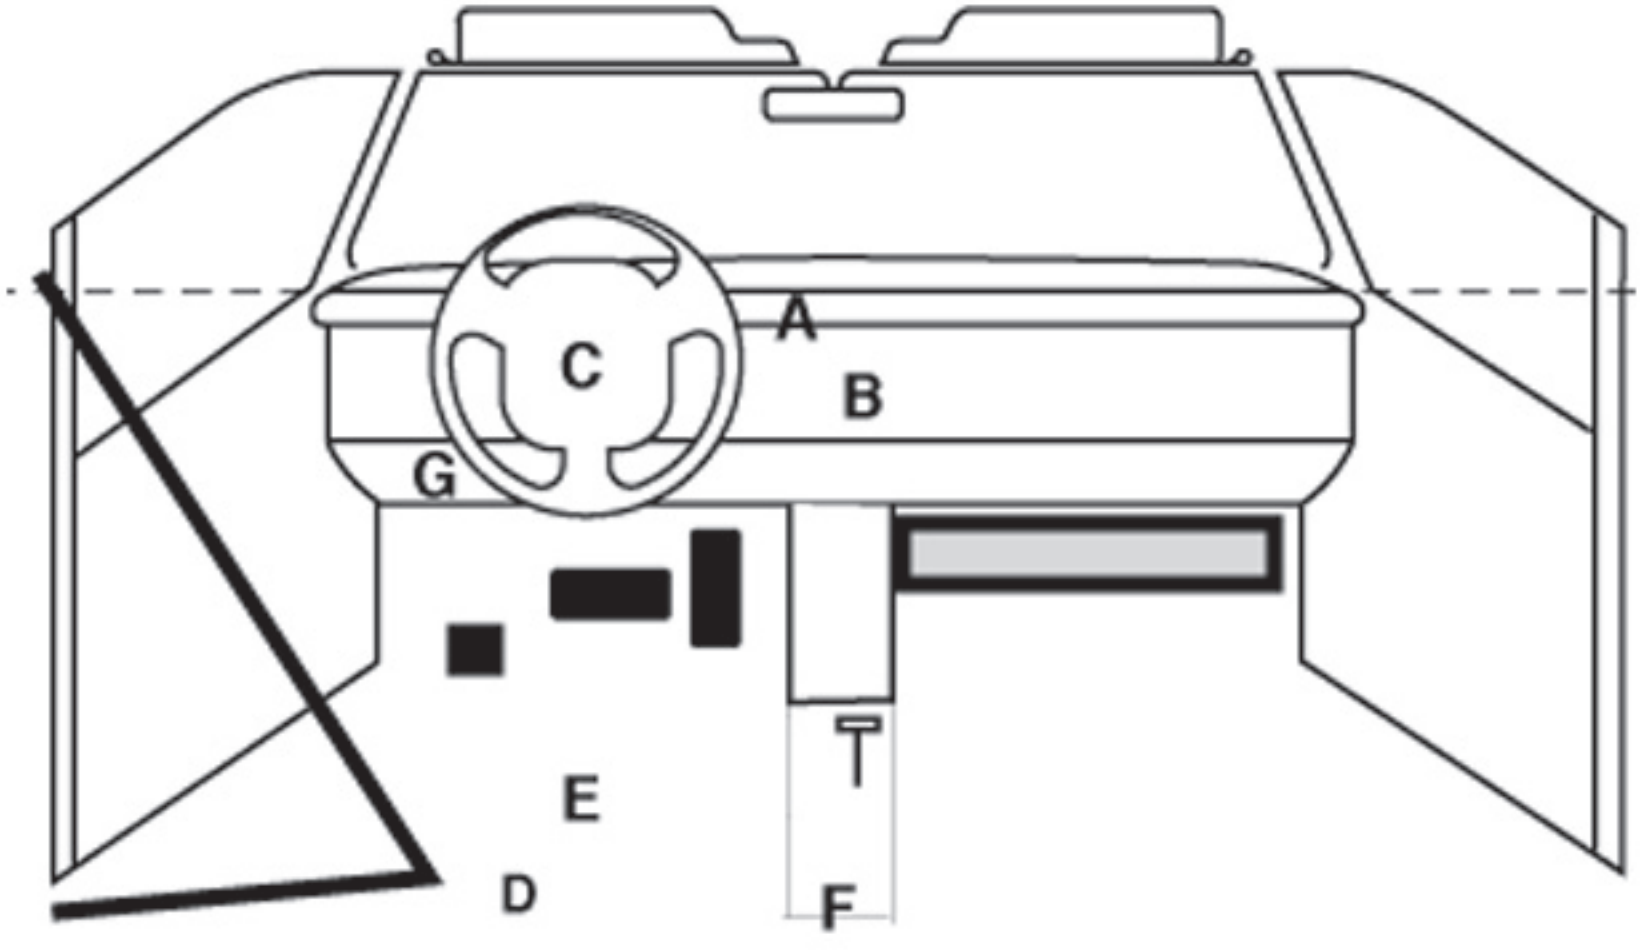
A = upper IP, white scuff
B = radio, cracked
C = SW airbag, blood
D = DR seatbelt, load marks
E = DR seat cushion, blood stain
F = center armrest, blood stain
G = knee bolster, displaced
